TB10047

Topic: MIX font button upgrade		TB No.: 10047	Date: 21/03/2018
Affected Machines:	MIX Font, 1 button (P/N 1000878) & 3 button (P/N 1000879)	Priority: Low	Created By: Gareth Fitzpatrick
From Serial No.:	>0817xxxx <0218xxxx	Reason:	Part update
From Date:	Aug 2017 to Feb 2018	Pages:	1/2

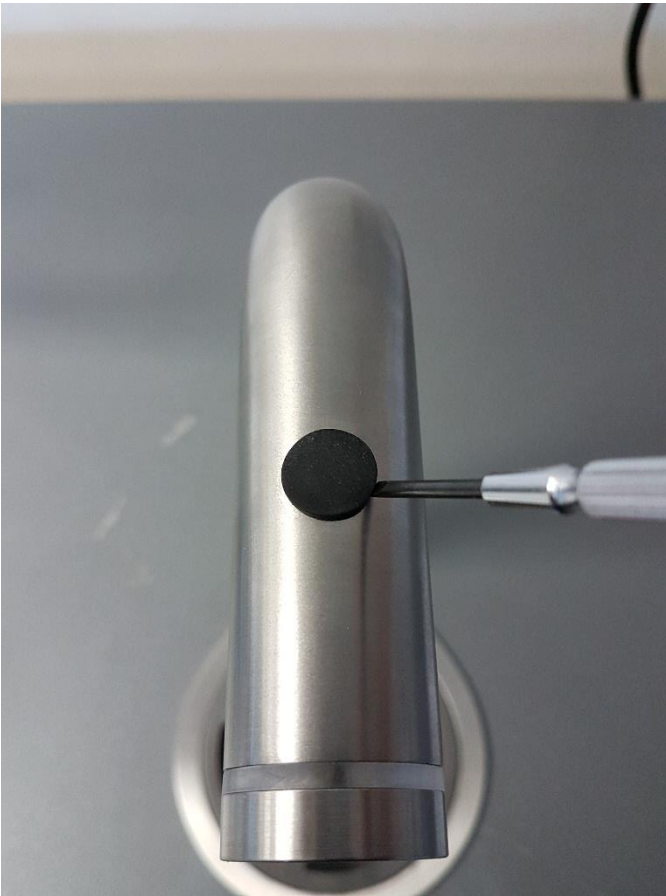
Fig 1.0

It has come to our attention that a small batch of MIX font button material of the following serial range >0817XXXX TO 0218XXXX is defective. The particular batch has a weakened material resulting in premature wear after a short period. The button will deform out of shape. The affected part No of the button is **1860361**.

1. Power down the boiler at the mains power supply before fitting the new button. The font ring light should not be illuminated.
2. Remove the defective button by prising free using a small size screwdriver. **Fig 1 & Fig 2**. Take care not to damage the tactile switch underneath the rubber button. See fig 3.0 to view the PCB and tactile button.
3. Slot the new button into the hole by pressing firmly around the edges until the lip is secure in the hole. **Fig 3 & Fig 4**.
4. For three button models (MIX FONT THREE BUTTON **P/N1000879**) replace all three buttons.
5. Power back on the boiler and test by pressing the button.
